**REPORT**

**ROYAL COMMISSION**

**FAILURE OF**

**WEST GATE BRIDGE**

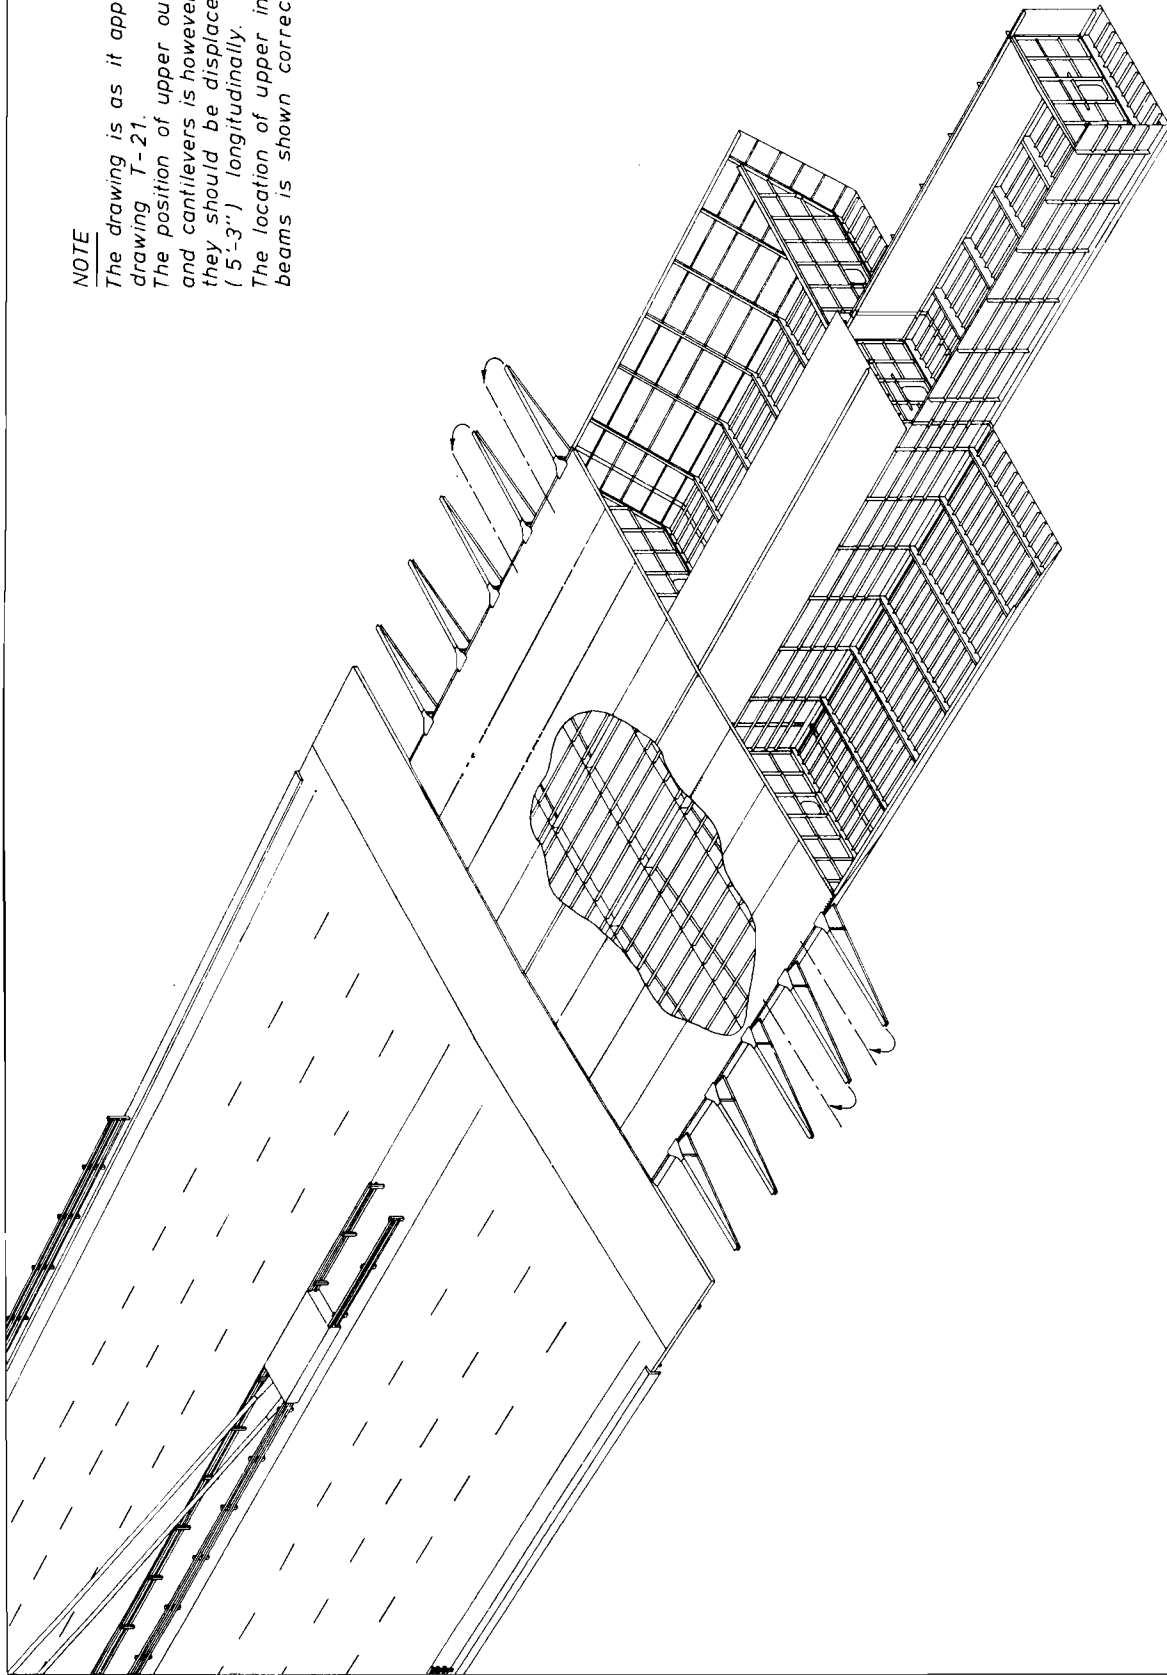
FIG. 4

The drawing is as it appeared on the tender drawing T-21.  
 The position of upper outer transverse beams and cantilevers is however incorrectly shown, they should be displaced one half pitch (5'-3") longitudinally.  
 The location of upper inner transverse beams is shown correctly.

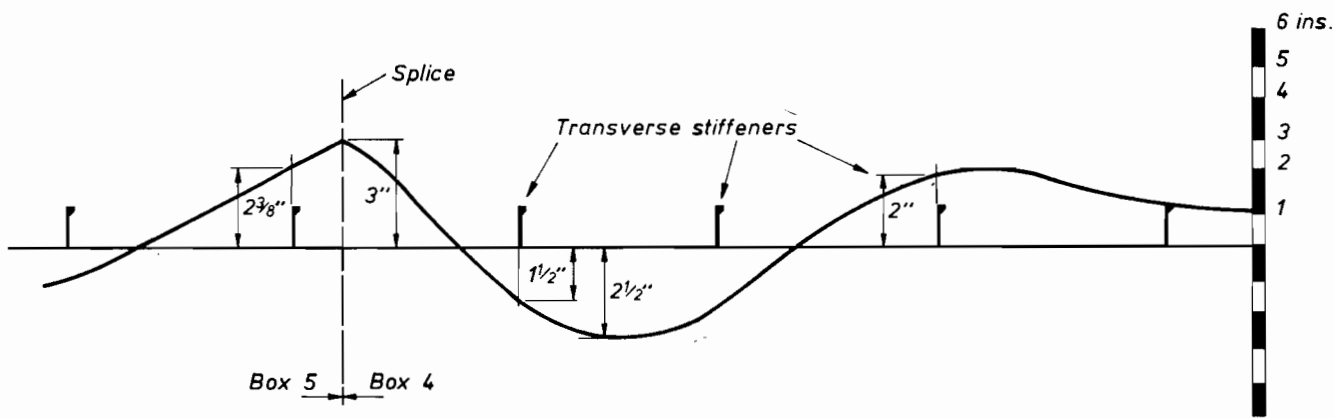
FIG. 10. BUCKLED SHAPE AT OUTER LONGITUDINAL STIFFENER SPAN 14-15N.

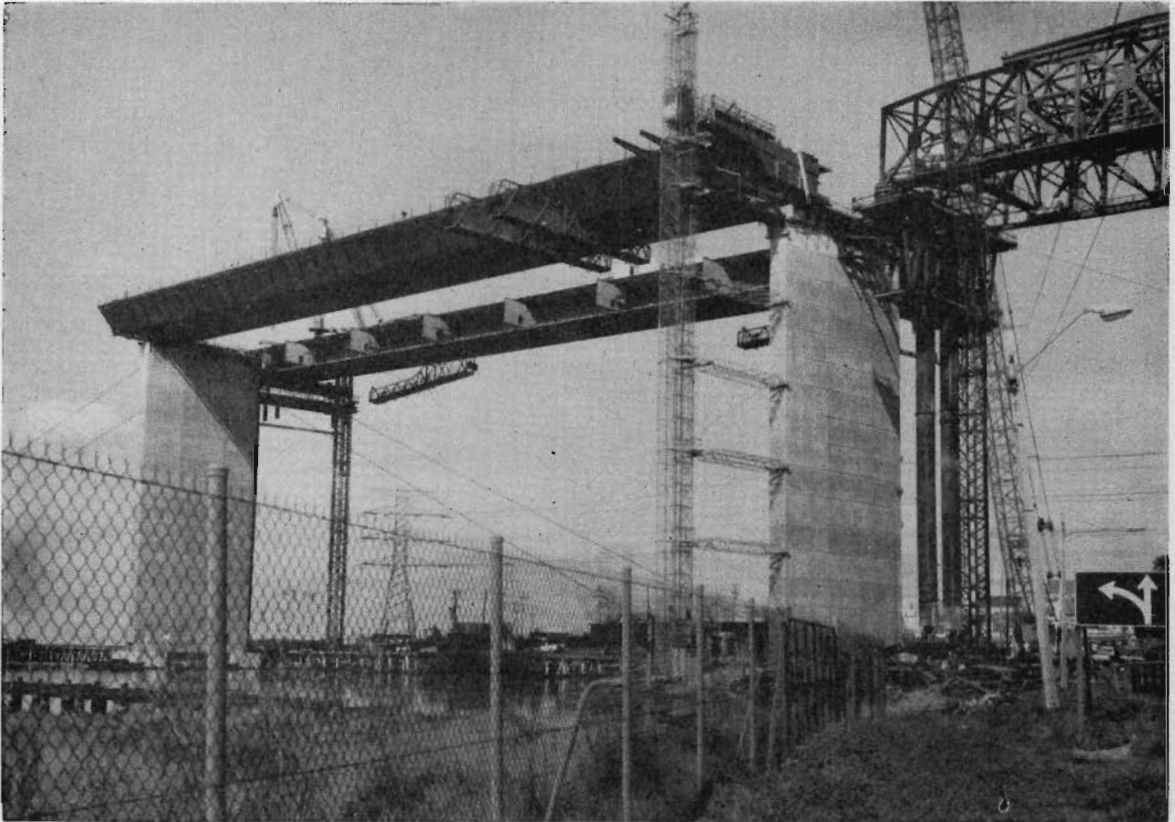
PLATE 2. SPAN 10-11, SHOWING SOUTH HALF SPAN BEING JACKED UP.  
Note : Transverse diaphragms are projecting out of south half span.

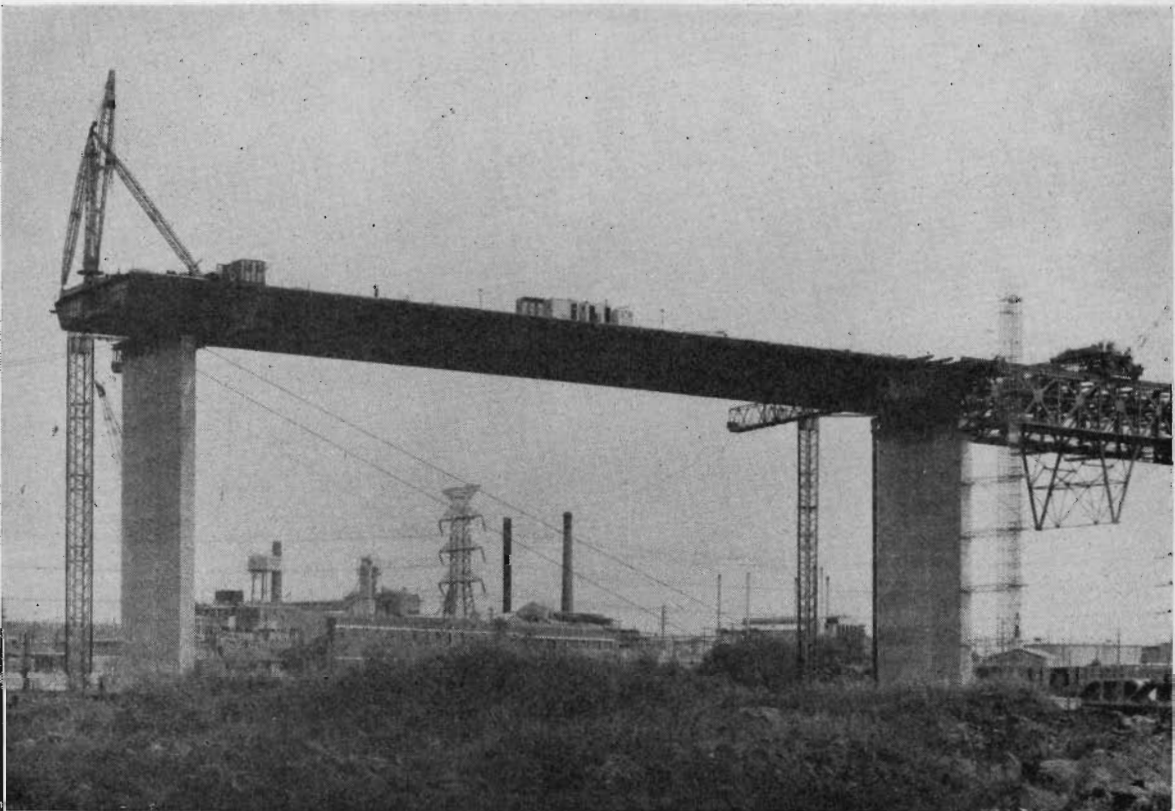
PLATE 3. SPAN 10-11 SHORTLY BEFORE THE COLLAPSE.

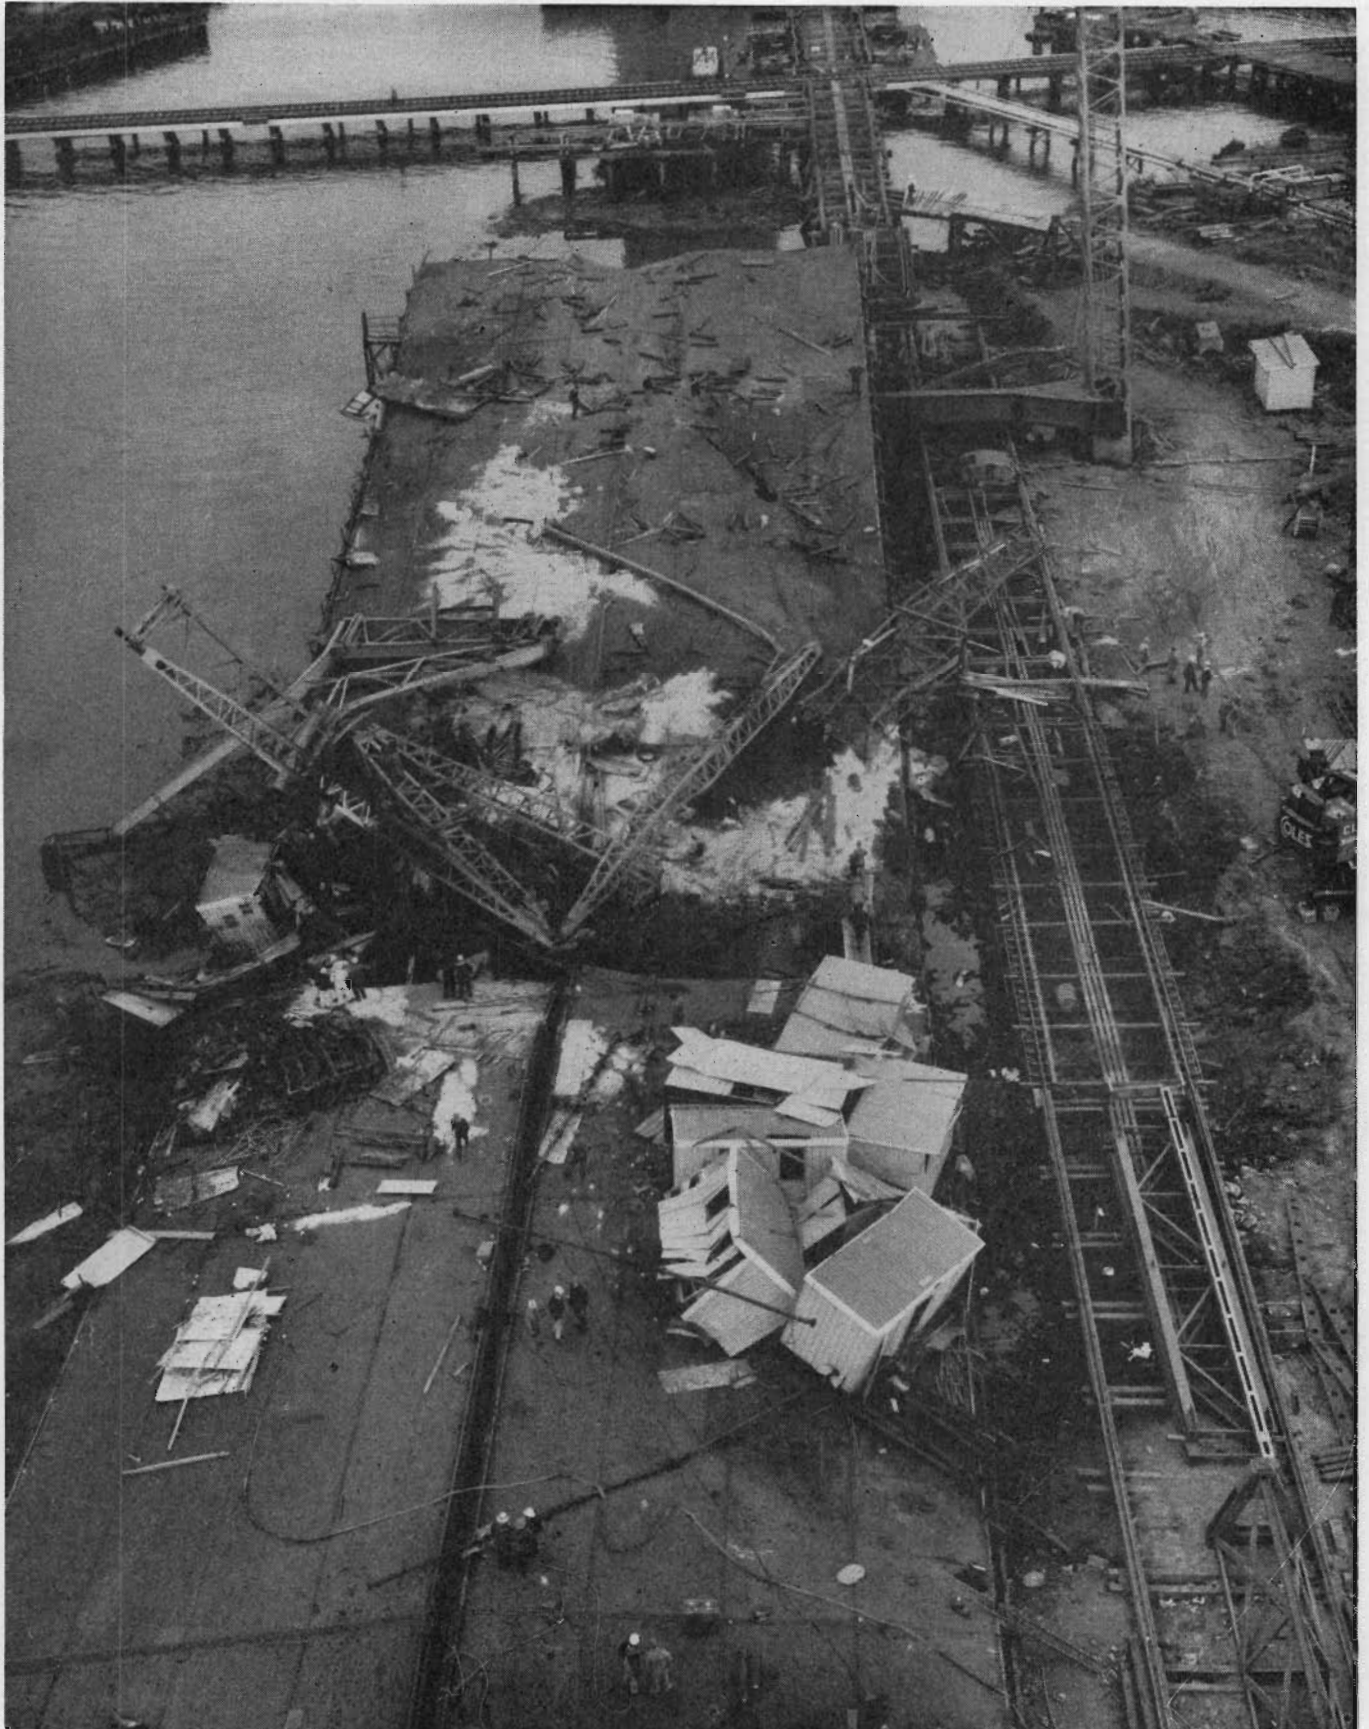
PLATE 1. VIEW OF COLLAPSED SPAN FROM TOP OF PIER 10.

Note : Longitudinal splice is open on boxes 1-3, in foreground. The stiff-legged derrick was attached to box 8 (top right-hand corner) before collapse.

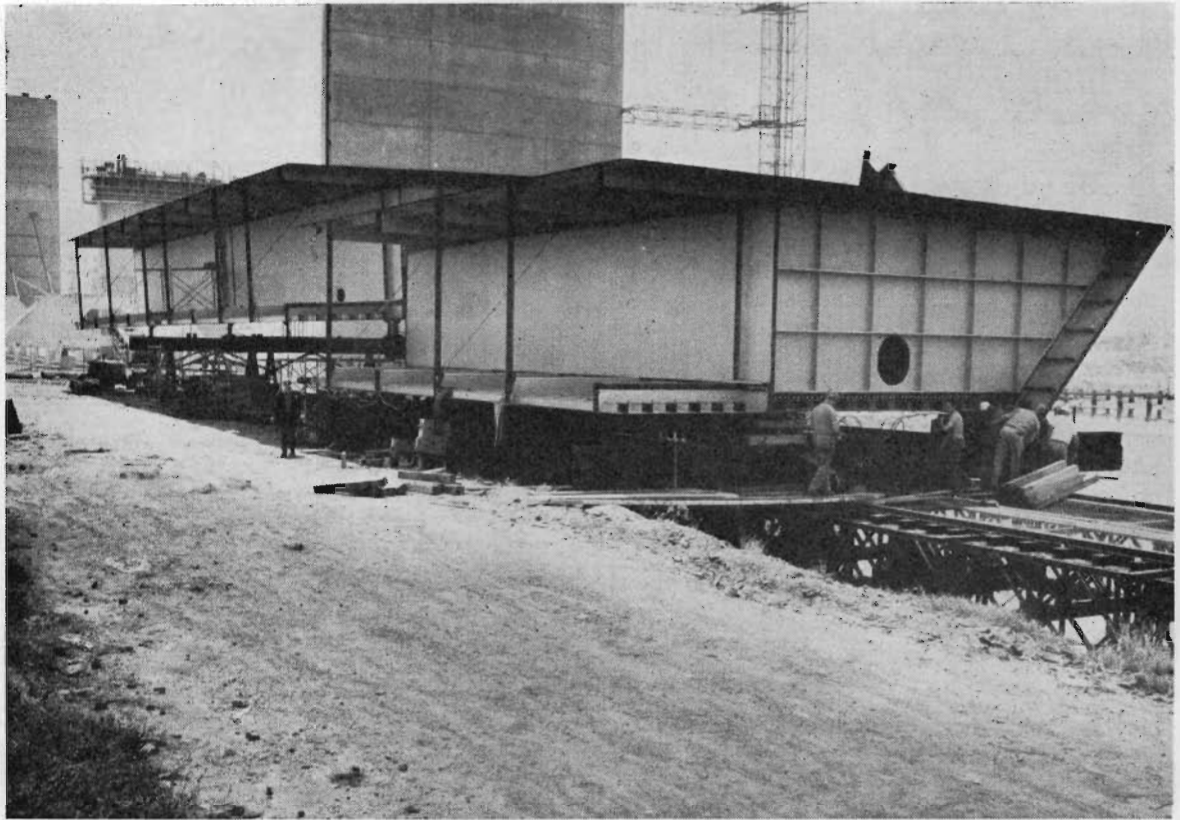
WSC had indeed provided some sort of support to the upper transverse beams, but this, we believe, was intended only for the purpose of stiffening a box during handling and transporting. Whatever its purpose, the bracing provided proved quite inadequate to prevent the instability which did in fact take place. Details of the temporary braces provided by WSC for the 14-15 north span can be seen on Plates 2, 4 and 6. In general, an angle iron tie was bolted between the tips of the upper and lower transverse beams and a wire rope brace, with turnbuckle, was fixed diagonally from the tip of the bottom transverse beam to the root of the upper beam, i.e., to the point where it joined on to the inner web. This system gave some partial fixity to the upper beam and the presence of the wire rope brace would prevent gross downward movement of the tips of the transverse beams. There was little to prevent upward movement and in any case this bracing was provided only at every other transverse beam.

PLATE 4. TYPICAL BOX SHOWN READY FOR BOLTING TO HALF SPAN 10-11 NORTH.

Note : Temporary wire braces and vertical posts were fitted during handling of boxes.

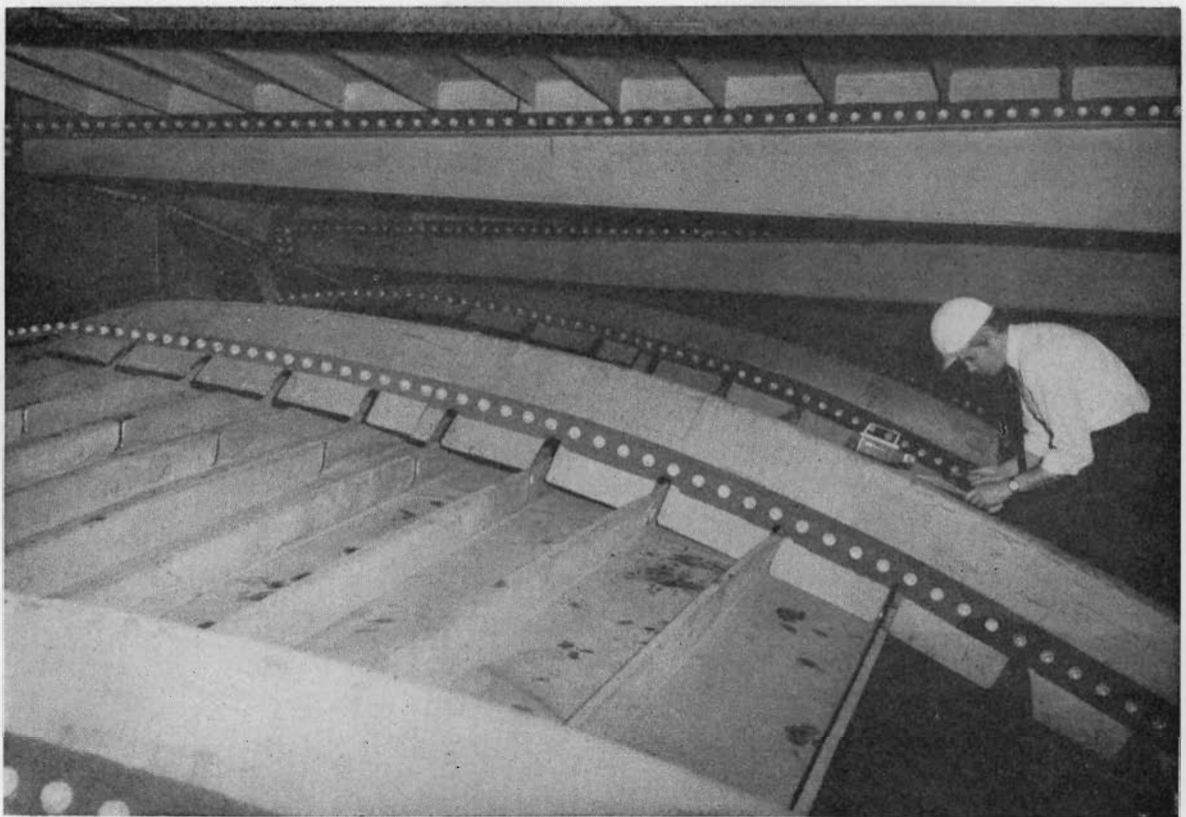
PLATE 5. INSIDE BOX 4, OUTER CELL AFTER COLLAPSE.

Note : Bottom flange has been forced up about 8 feet. Transverse beams were not welded to flange plate but have torn off the welds connecting them to the bulb flat stiffeners.

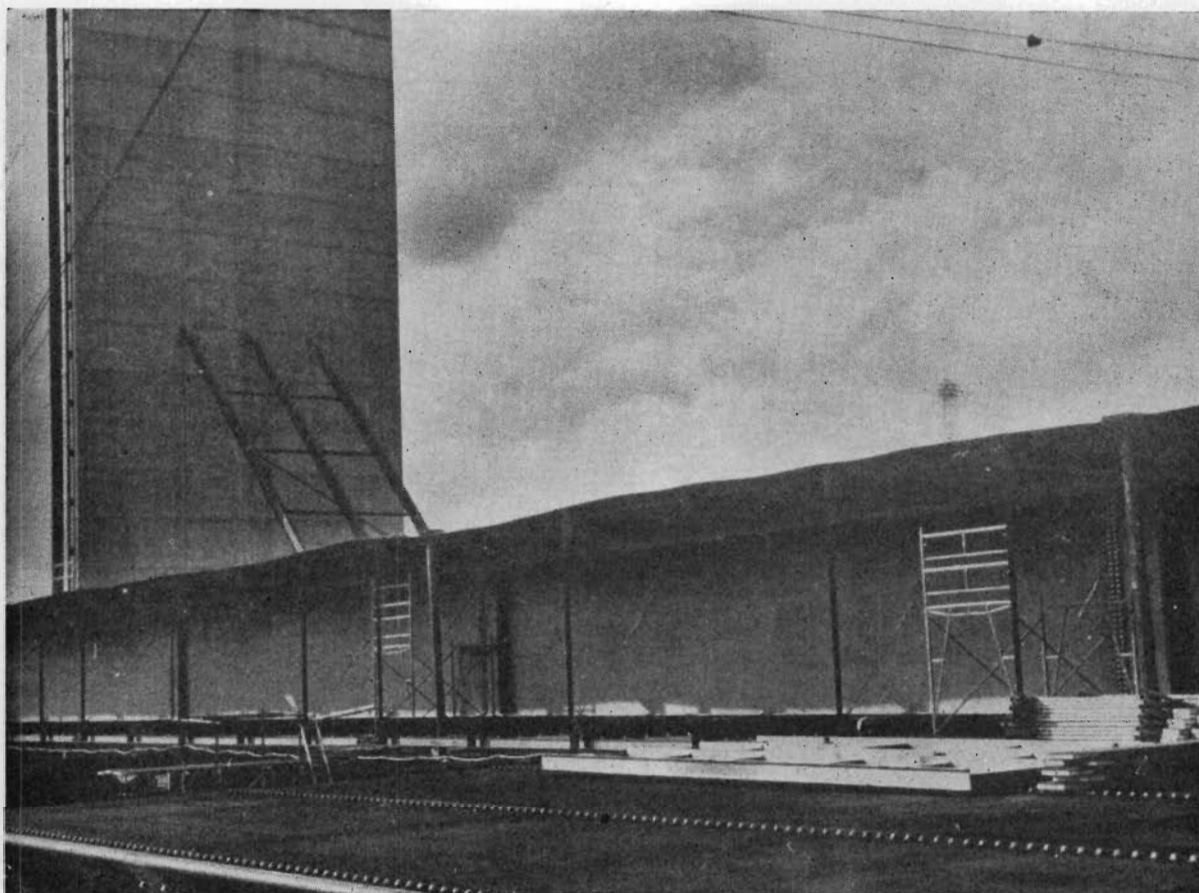
Once the bolting together was completed the span was lifted off the temporary staging so that it spanned freely between the jacking beams at either end. At this stage significant compression instability was observed in the projecting flange plates of the inner upper panels.

This instability resulted in severe buckles to the plate edge and also to the outermost bulb flat stiffener. The buckles in the plate edge were stated to be as much as 15 inches deep ; they can be seen on Plate 6. The amplitude of the plate buckle reduced away from the free edge until it disappeared at the connection with the inner longitudinal web plate. The extent of buckling of the outermost bulb flat longitudinal stiffener is shown in Fig. 10, from a survey made at the time. The sharp kink shown over the transverse splice was associated with a crippling failure of the fish plate which splices the bulb flat stiffeners (referred to in this Report as a K-plate). It is evident that both the flange plate itself and the bulb flats were bent beyond the elastic limit although this fact does not appear to have been appreciated at the time. Surveys made at the request of the Commission have confirmed that post elastic distortion is still present in the affected panels, some longitudinal stiffeners being as much as  $\frac{3}{8}$  inch out of straight in a length of 10 ft. 6 in. between transverse ribs.

To understand the causes of this instability, it is necessary to refer to the details of the structural arrangement in Section 3.2.1., wherein it is pointed out that the transverse beams under the inner upper panel do not fall opposite the transverse beams in the outer upper panels so that there is no possibility of continuity from a beam of the outer panel to one of the inner panel. The transverse beams of the inner panel are bolted to the  $\frac{3}{8}$ -in. inner web plate at one end but during erection are entirely free at the other end. They are, in effect, cantilevers with a very limited moment capacity at the root and can give little resistance to their outer ends being distorted up or down when the main flange plate becomes unstable.

It is easy to see how, in these circumstances, instability could occur. The remedy by a more effective bracing system is equally apparent. What is so hard to understand is why this obvious difficulty was not anticipated by WSC in drawing up their erection proposals and secondly why the defect was not detected by FF & P when it was their duty to check the safety of the proposed erection method.

PLATE 6. BUCKLE ON INNER UPPER PANEL 14-15 NORTH.  
 Note : Effective diagonal bracing was not fitted.

The buckled plate edges were pulled into line by fitting a 6-in. universal beam on the underside of the longitudinal splice between north and south boxes. Normally only an upper cover plate was specified. By means of specially long bolts the buckles were pressed out between the upper cover flat and the stiff beam section underneath. Once the plates had been brought into line the temporary long black bolts were removed, one at a time, and replaced with the final friction grip bolts. The distorted transverse beams on the north half girder were easily forced back into line and bolted to the ends of their opposite numbers on the south side.

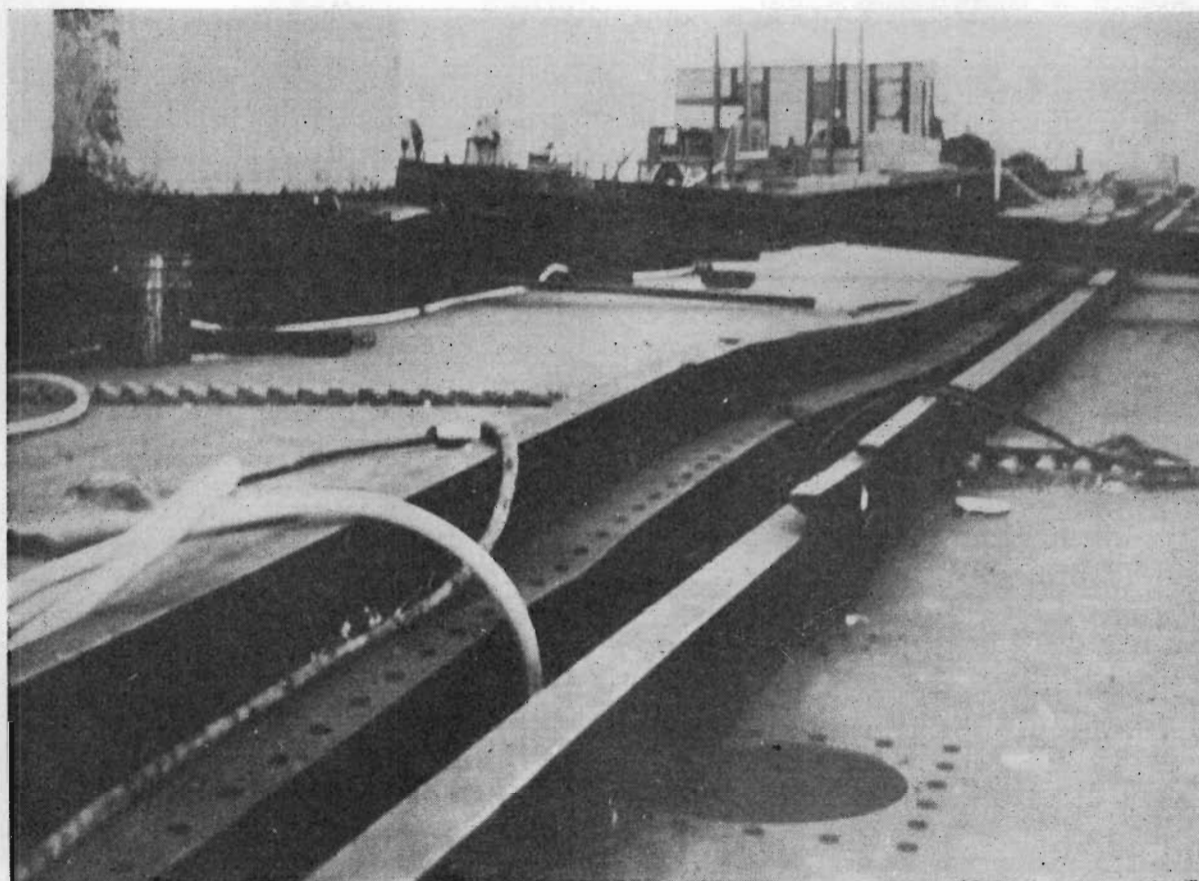
Bolts were removed from one side of the transverse joint between boxes 4 and 5 and also at the same time from the joint between boxes 5 and 6 ; they were not jammed in the holes and came out easily. Unbolting started at the longitudinal centre line and worked across the seam to within about 2 feet of the line of the inner web, i.e., about 30 bolts on each line. This virtual isolation of the inner upper panel of box 5 had the desired effect of flattening out the remaining bulge. The movement of the plates at the splice was only slight and it was found possible to re-enter new bolts with only minor reaming of holes. The K-plates splicing the longitudinal bulb flat stiffeners were not unbolted during the whole of this operation and were stated to have shown no sign of damage, despite the fact that they must have been called upon to carry some of the load shed by the plate when the transverse seam was opened up.

Although it apparently achieved its object, this operation was a regrettable necessity. The act of releasing plates while under stress means inevitably that some other parts of the section must carry the load. The relaxed plates can never return to the same strain condition that they would have had if they had not been disturbed. The consequential redistribution of internal stress which was not envisaged when making the design calculations, would almost certainly cause some reduction in the real safety margin on the span.

PLATE 7. BUCKLE ON INNER UPPER PANEL 10-11 NORTH.  
 Note : Two of the blocks of kentledge can be seen, top left. The transverse seam 4-5 which was undone appears at mid-height.

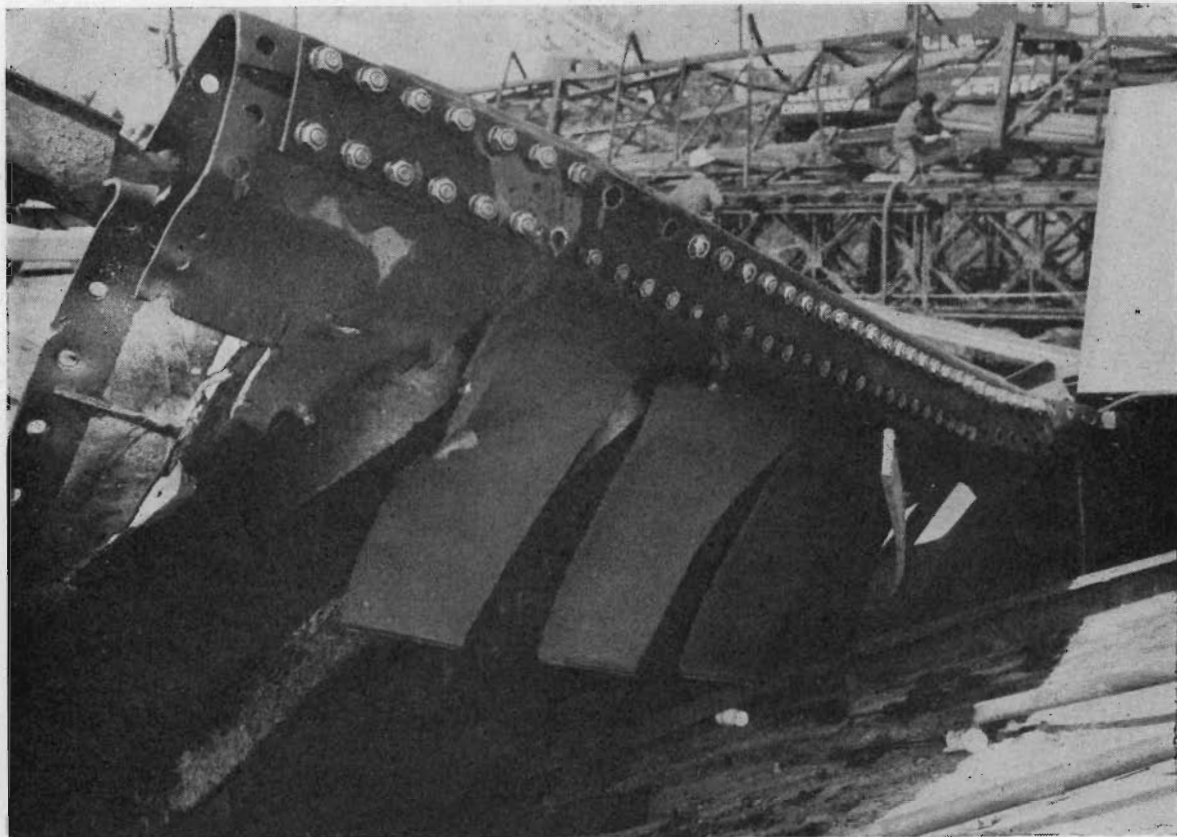
There can be no doubt that the particular action which precipitated the collapse of span 10-11 was the removal of a number of bolts from a transverse splice in the upper flange plating near to mid-span. These bolts were removed in an attempt to straighten out a buckle which had occurred in one of the eight panels which constitute the upper flange. The buckle, in turn, had been caused by the application of kentledge in an attempt to overcome difficulties caused by errors in camber.

PLATE 8. TRANSVERSE SPLICE 4-5, INNER UPPER PANEL, AFTER COLLAPSE.

Note : These are the bolts which were undone on 15th October. The bridge centre line is on the right of the photograph. The bulb flat stiffeners have torn triangular pieces out of the deck plate.

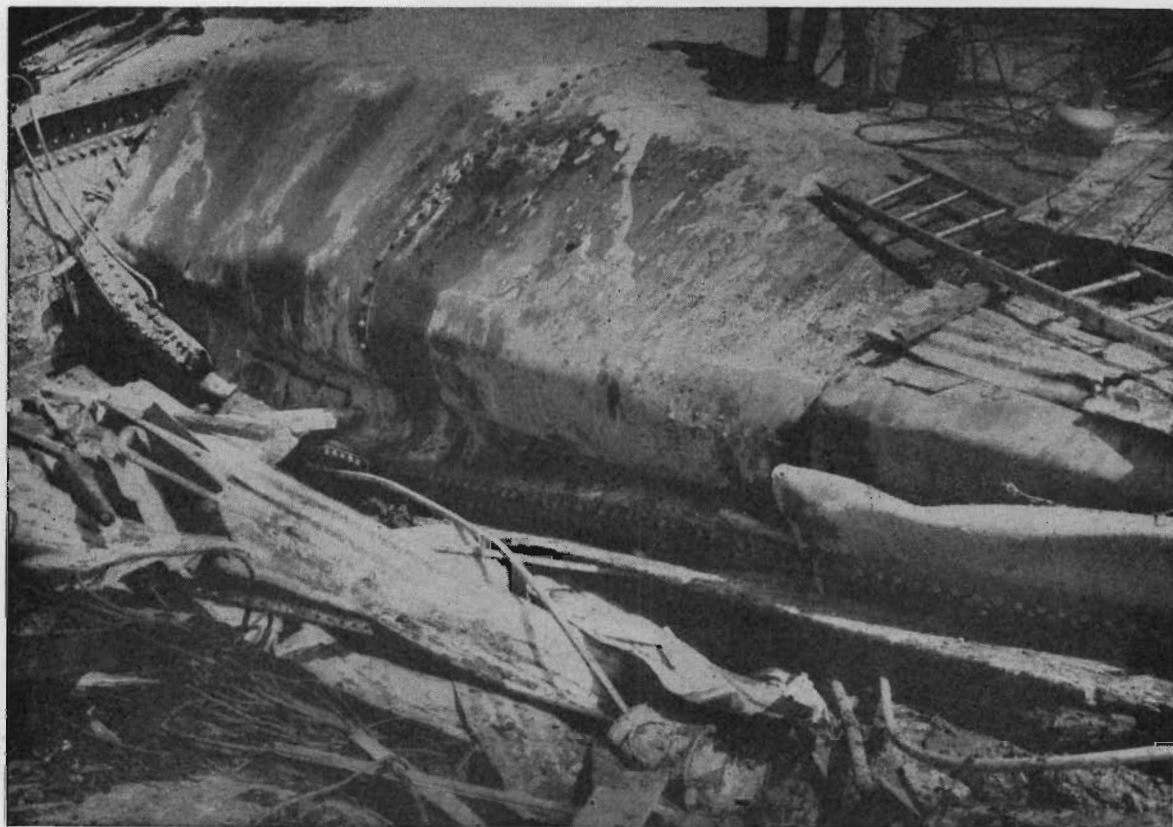
PLATE 9. TRANSVERSE SPLICE 4-5 NORTH, OUTER PANELS, AFTER COLLAPSE.

Note : The excessive folding of flange plate can be seen. The inner web appears on the left of the photograph. This is the area affected by fire.

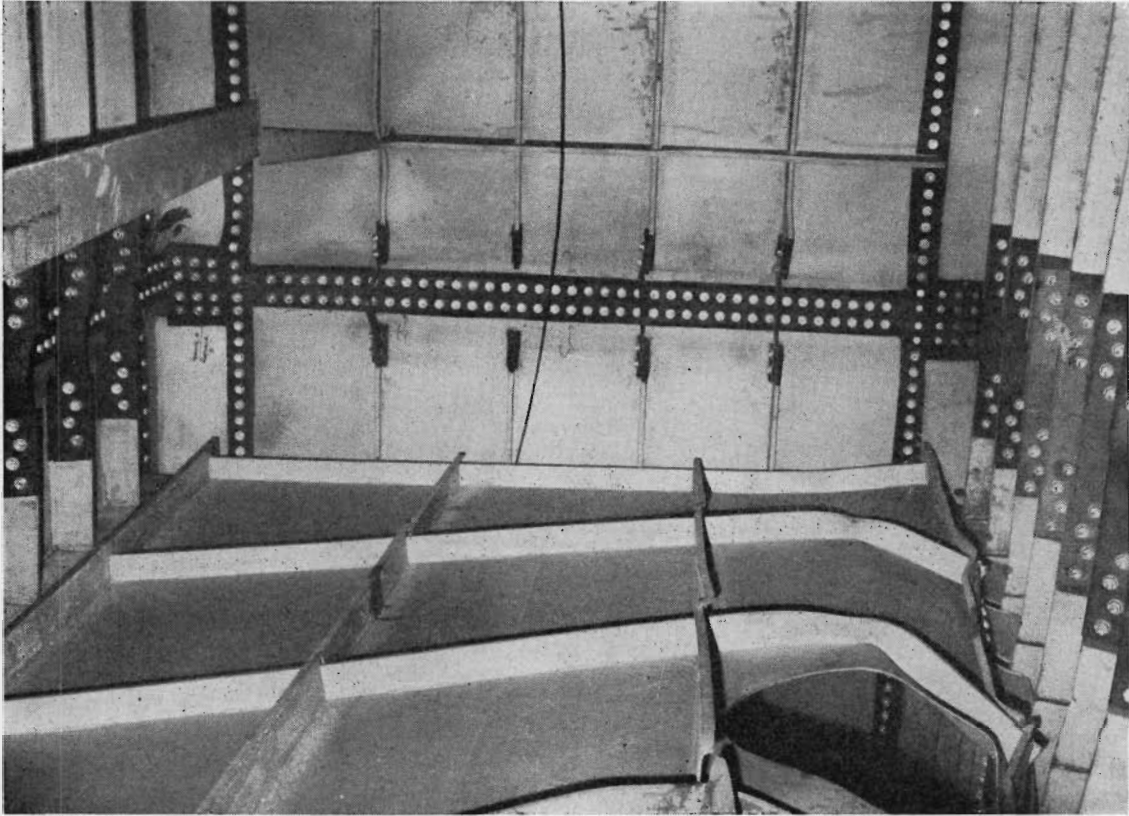
PLATE 11. TRANSVERSE SPLICE 2-3 AFTER COLLAPSE—FROM INSIDE OUTER CELL OF BOX 3.

Note : Buckled K-plates can be seen on inner web and upper flange. The third K-plate up on web was never fitted. The crippling of the M.S. web at the top can be seen.

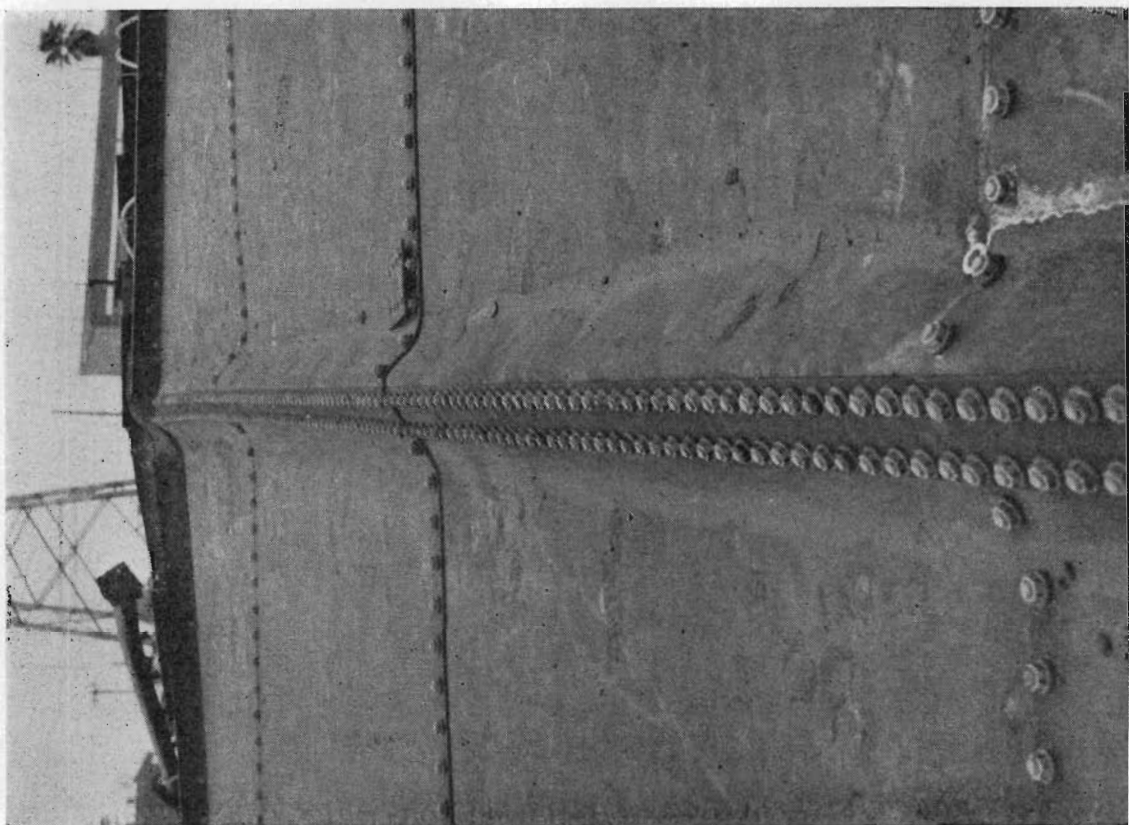
PLATE 10. TRANSVERSE SPLICE 2-3 AFTER COLLAPSE.

Note : This damage was almost certainly due to impact of the falling span. The photograph shows the form of buckling that can accompany the collapse of the K-plates.

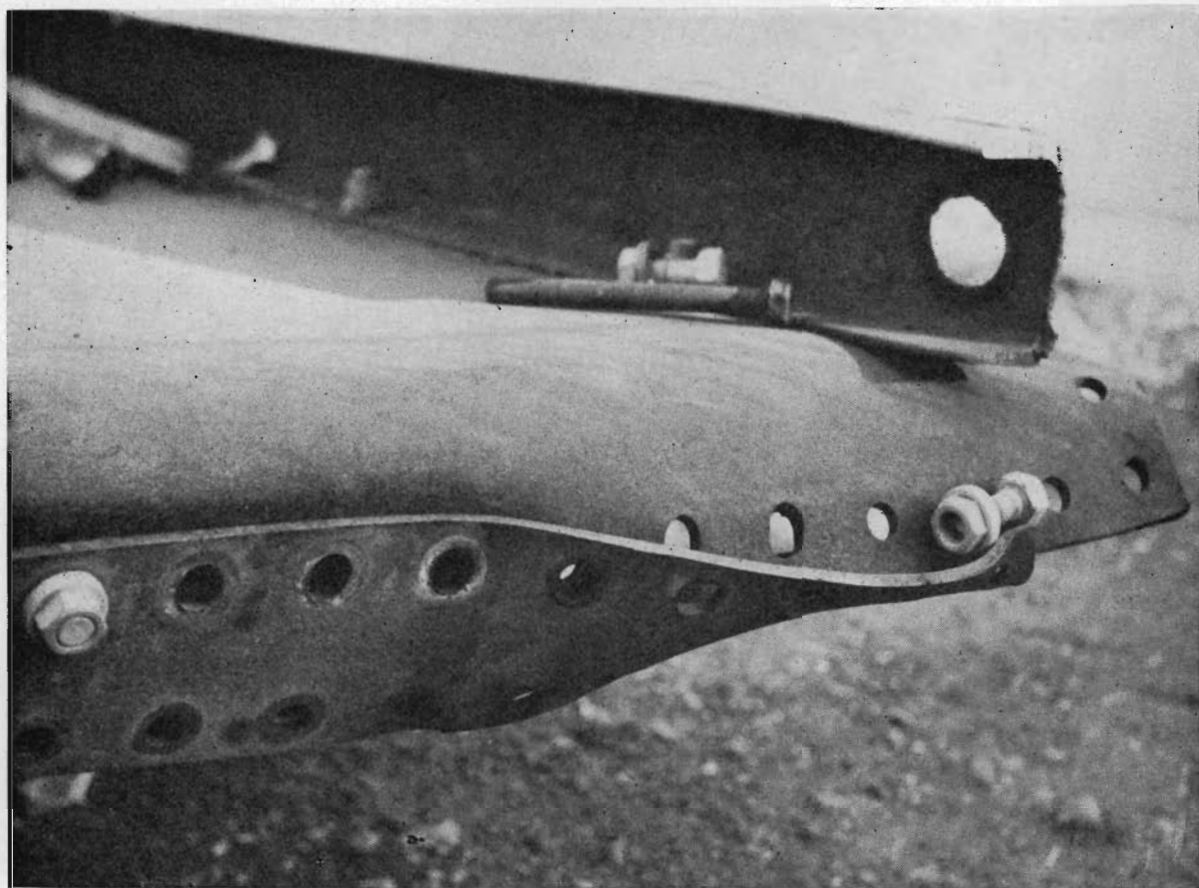
PLATE 12. DETAIL OF 4-5 NORTH SPLICE CUT OUT FROM WRECK.

Note : The extent of overdrilling can be seen on some holes. It appears that the last few bolts were never replaced.

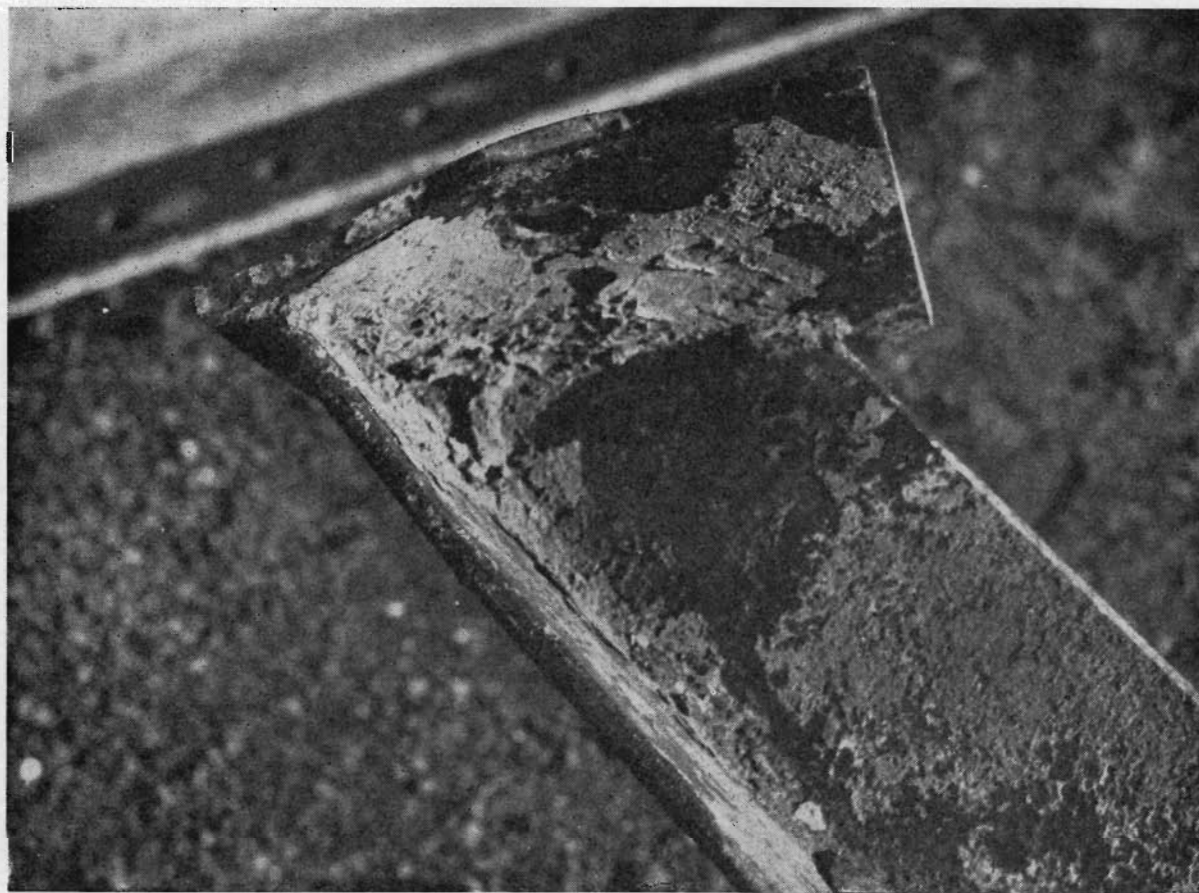
PLATE 13. END OF DIAGONAL BRACE FROM BOX 4 NORTH SPAN 10-11.

Note : The distortion of the end plate can be clearly seen.
