**REPORT**

**ROYAL COMMISSION**

**FAILURE OF**

**WEST GATE BRIDGE**

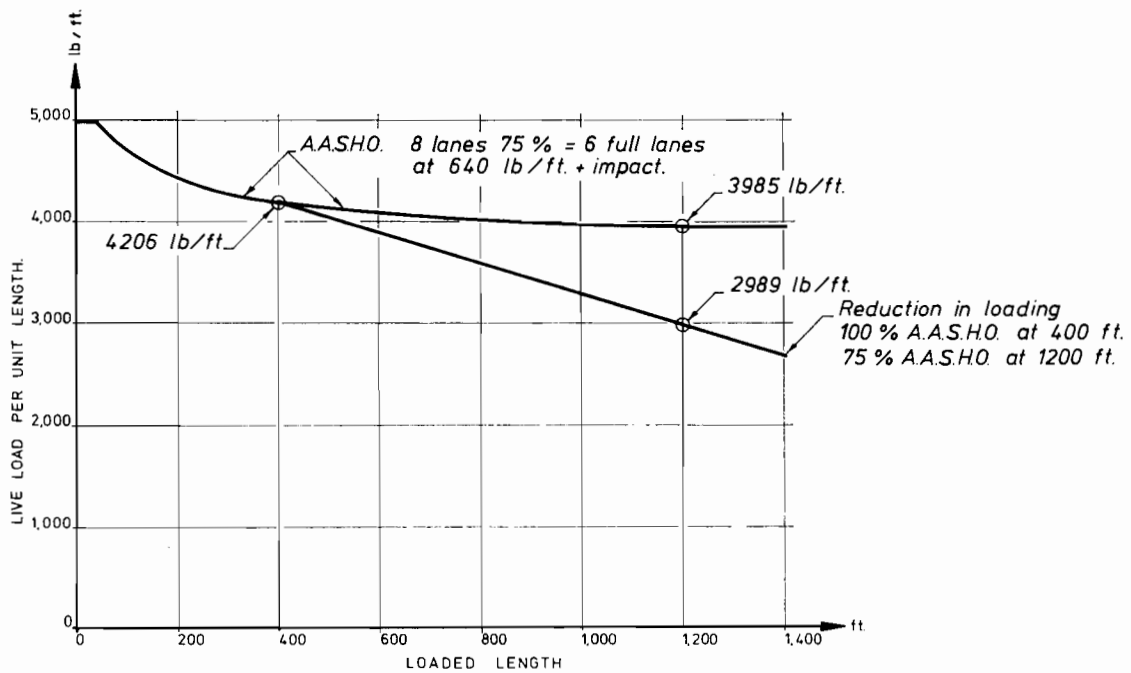
FIG. 11. LIVE LOAD CURVE FOR 8 LANES.

So far as live load is concerned, FF & P stated to the Authority that the bridge was designed generally in accordance with N.A.A.S.R.A. 1965 specification for H20-S16-44 loading, but that "to make allowance for the probable reduction in load intensity and where applicable", a modified loading curve as shown in Fig. 11 was used.

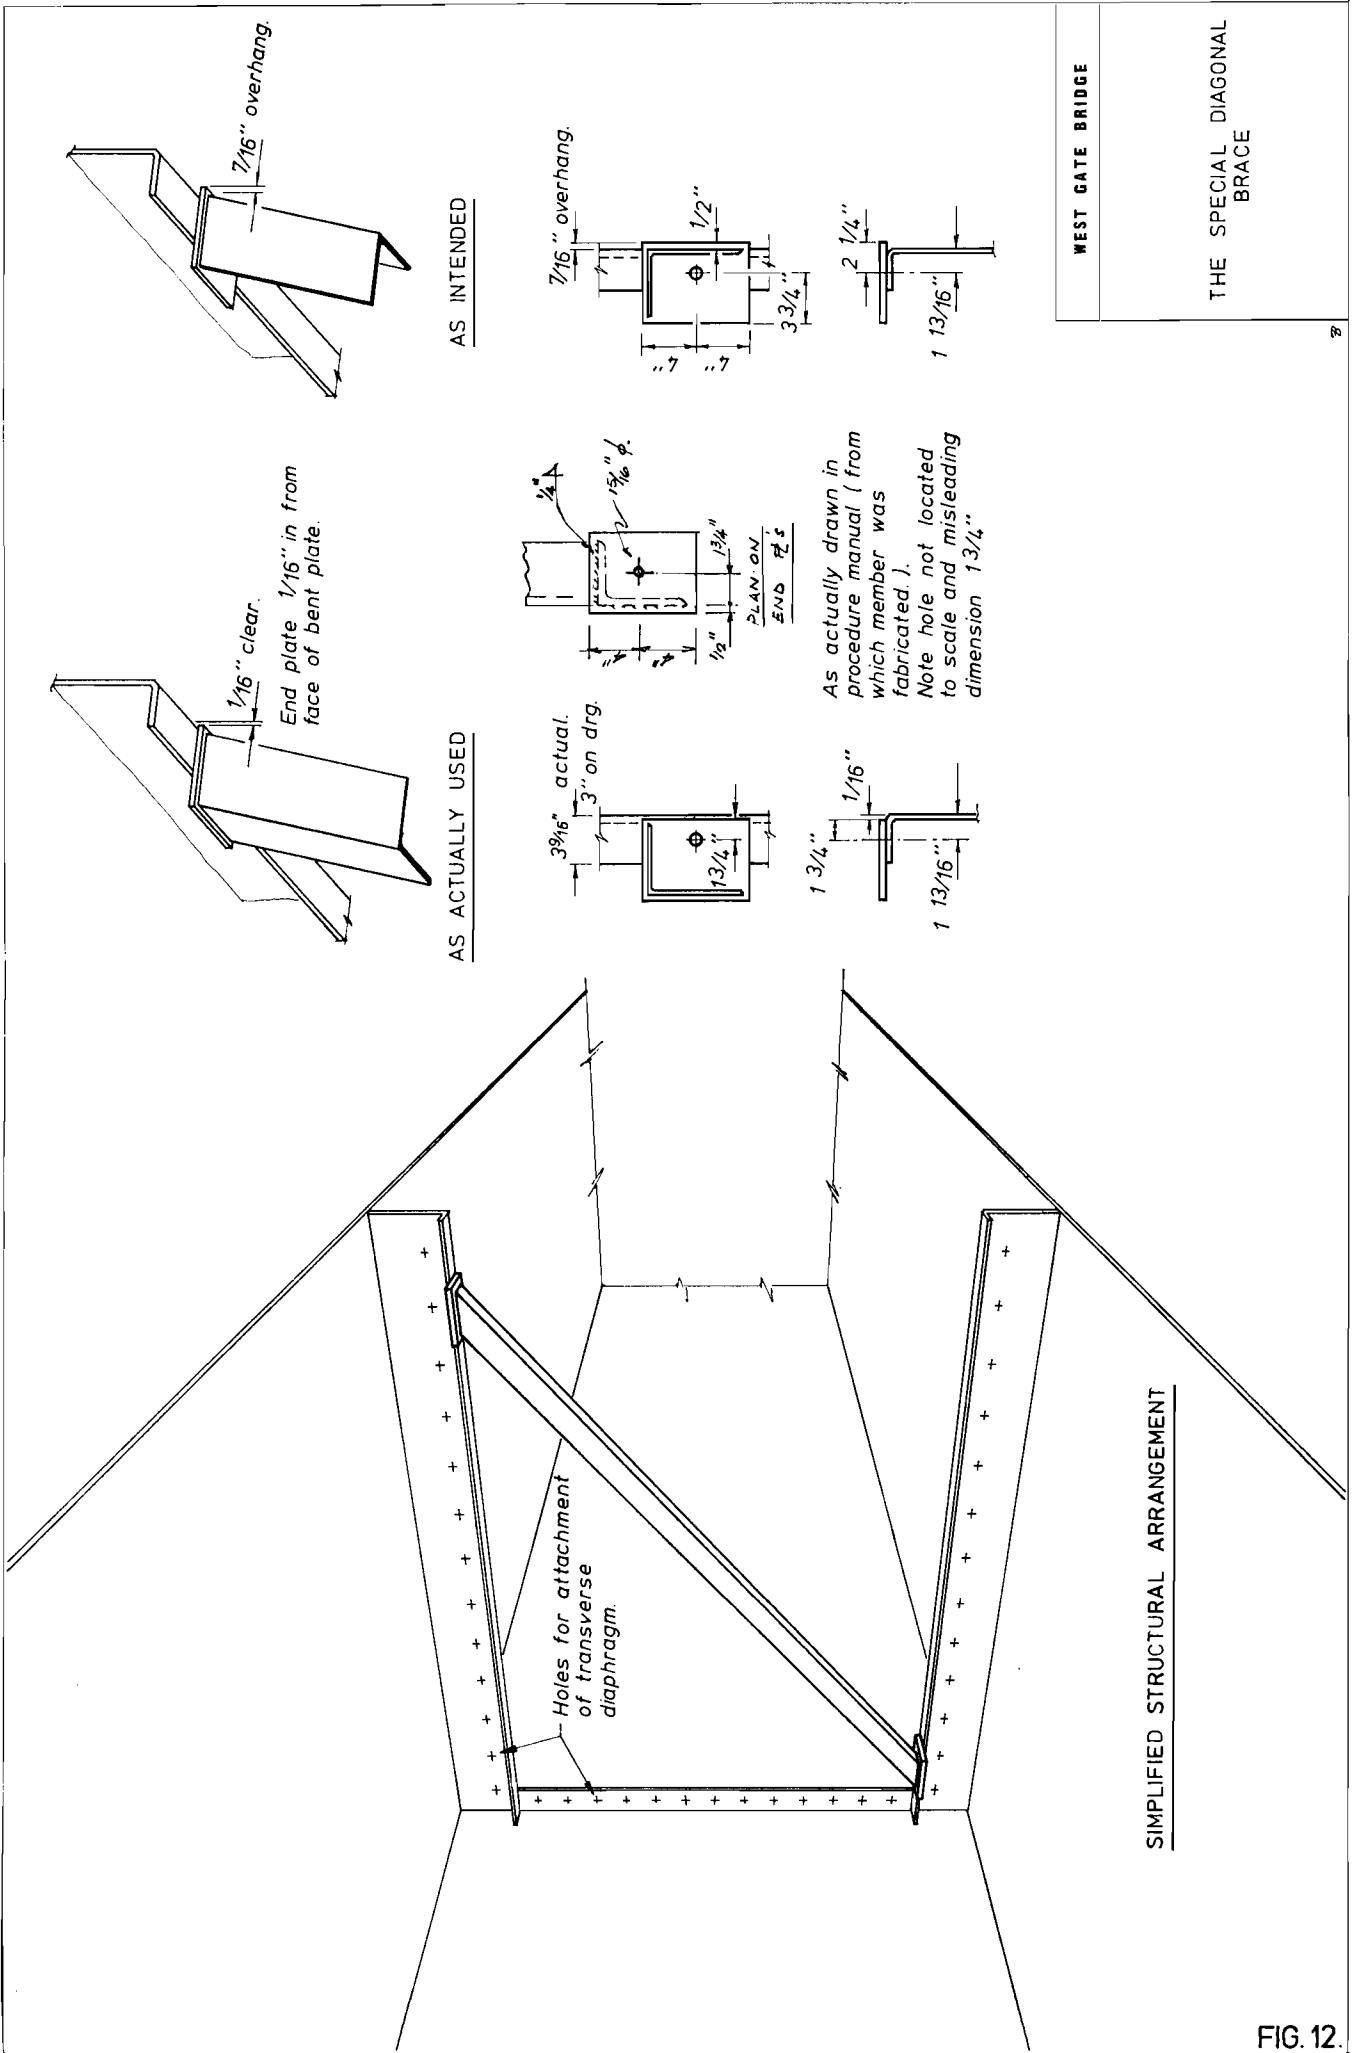
FIG. 12.

The details of the diagonal braces both normal and special, were fully set out in the Procedure Manual which also contained procedures for fitting them. The sketch of the end palm plate given there was not drawn to scale and the dimensioning was such as to lead to the possibility of misinterpretation. This was unfortunate as it appears the braces were made directly from the sketch in the Procedure Manual. On Fig. 12 is included an exact reproduction of this sketch, whereon it can be seen that the dimension "1 3/4 inches" below the bottom right-hand corner of the 8 in. x 6 in. end plate should really be the distance from the back of the angle to the centre of the hole. If the sketch had been to scale this would have been obvious. The fabricator, however, took the dimension to refer to the distance of the hole from the right-hand edge of the plate and in consequence he drilled the hole 2 inches away from its intended position. The sketch from the Procedure Manual incorporated another error in that the detail of the end plate as shown is "handed" for the east side and should have been made "opposite hand" for the west side. This was not realized by the fabricator and the members were made as drawn.

On the other hand a number of reliable witnesses gave evidence that the diagonal was indeed in place at all material times and several were able to describe in detail the damaged end connections after the buckle at 4-5 north had taken place. We have also examined the damaged brace itself, as recovered from the wreck, and noted that the plate distortions are consistent with the member having been subjected to an axial overload in tension, see Plate 13. This damage did not take place in the collapse on 15th October, because we are sure that by then the brace really had been removed.

WEST GATE BRIDGE  
THE SPECIAL DIAGONAL BRACE

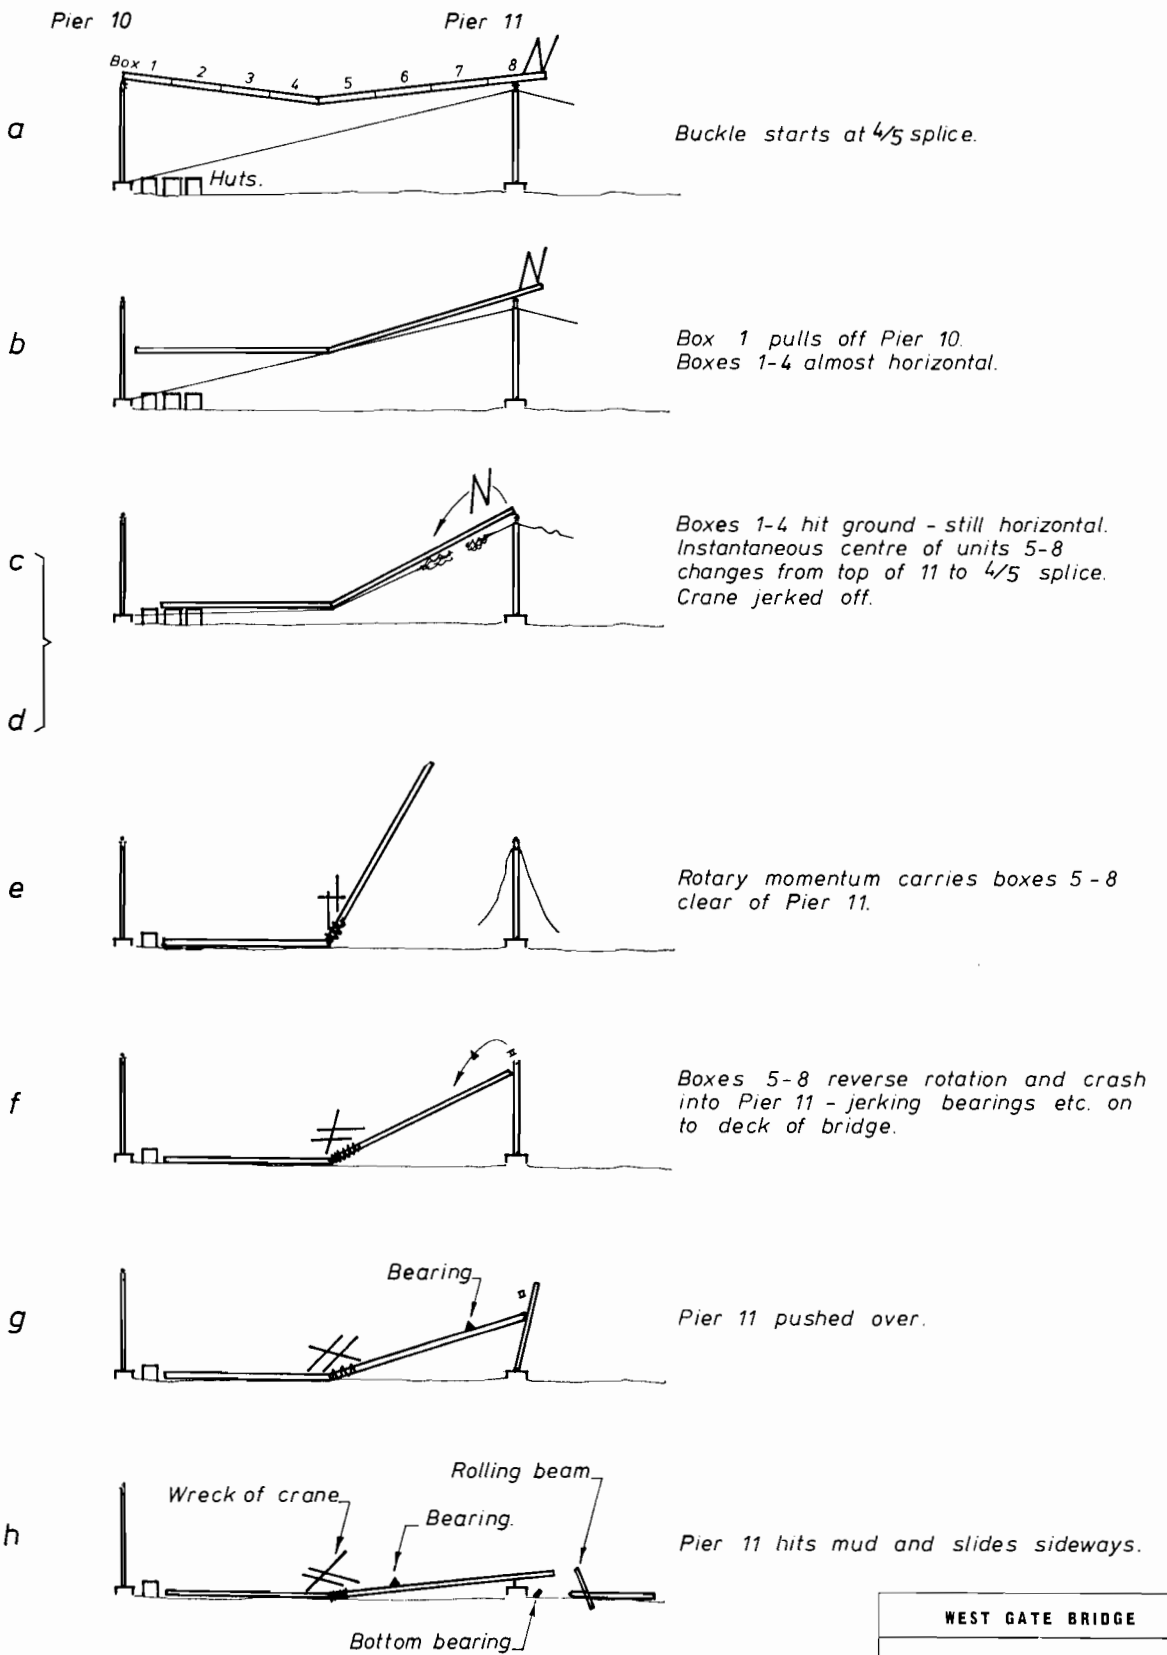
FIG. 13

This reconstruction of the dynamics of failure which is set out in diagrammatic form in Fig. 13 agrees well with the evidence of the witness Smith, who watched the collapse from the nearby public viewing area.

WEST GATE BRIDGE
DYNAMICS OF FAILURE
